Septodont Case Studies *Collection*

No. 06 - October 2013

Racegel : Gel Retraction Material

A four-year prospective study of the use of N'Durance[®] composite, a nano-hybrid resin

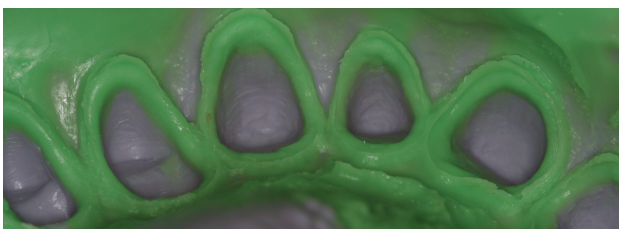
Fig. 1: An ideal indirect restoration impression. The material is void-free, clear of debris, and exhibits clean capture of the preparation margins.

In fixed prosthodontics, clinically acceptable impressions are an absolute necessity (*Fig. 1*). The laboratory fabricating the restoration is limited in its final quality by the quality of the incoming impression. The unfortunate reality is that most impressions are clinically unacceptable.¹

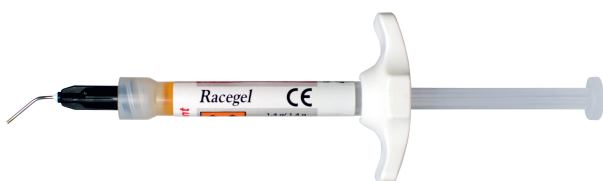
Fig. 2: Racegel is dispensed from a single-barrel syringe. It is colored to allow easy visualization in placement and to aid in verification of its removal.

This article will discuss impression techniques using a new gel retraction and hemostatic aid called Racegel (*Fig. 2*).

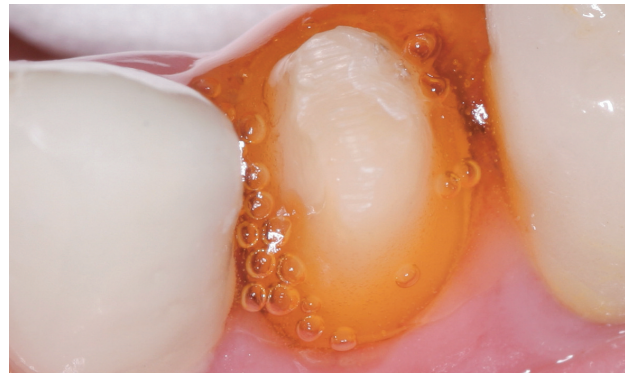
Fig. 3: In cases with a thinner gingival biotype, Racegel can be used as the sole source of hemostasis and tissue retraction.

This posterior crown is a common example of a low crest and deep sulcus restorative situation (*Fig. 3*). Because of the sulcus depth, often one cord is not adequate to fully displace the tissue and obtain a quality impression. Instead of traumatizing the tissue with two cords, one small cord was placed and then Racegel was injected into the sulcus. This provided the necessary retraction and hemostasis.

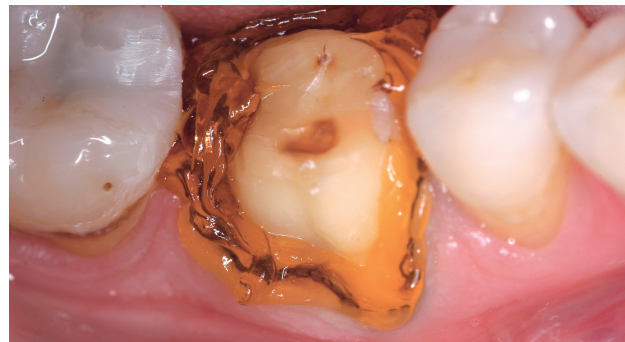
Fig. 4: In this case Racegel was being used in conjunction with a packed cord to control gingival bleeding and to aid in tissue retraction.

All-ceramic preparation margin designs will often be at the level of the gingival margin (*Fig. 4*). The premolar seen in this figure, which has a normal gingival biotype, can be readied for impression with Racegel as the sole source of retraction.

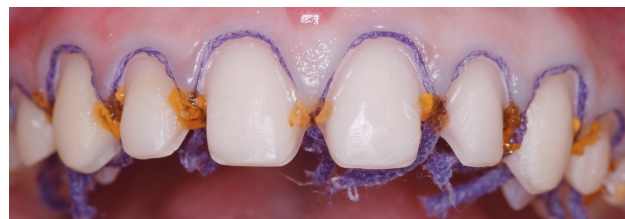
Fig. 5: In this multi-unit case, Racegel was used in conjunction with cord to control interproximal bleeding.

Preoperatively, this case had generalized interproximal decay and decalcification (*Fig. 5*), which resulted in residual interproximal inflammation and bleeding at the preparation visit. Dry cords were placed in the sulcus, and Racegel was placed on the bleeding areas. By controlling the tissue and obtaining a high-quality impression (*Fig. 6*), properly fitting restorations were created that allowed optimal health postoperatively (*Fig. 7*).

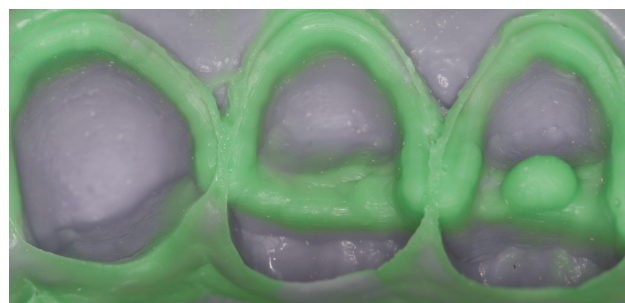
Fig. 6: The final impression from the case.

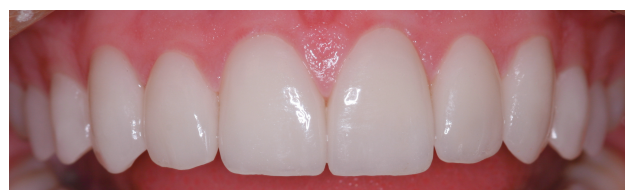
Fig. 7: The final lithium-disilicate veneer restorations. Note the healthy tissue response associated with properly fitting restorations.

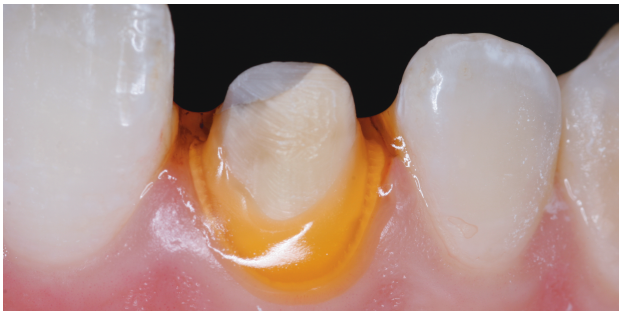
Fig. 8: An anterior crown preparation. This tooth had an average gingival biotype, which allowed the use of Racegel as the sole source of gingival retraction.

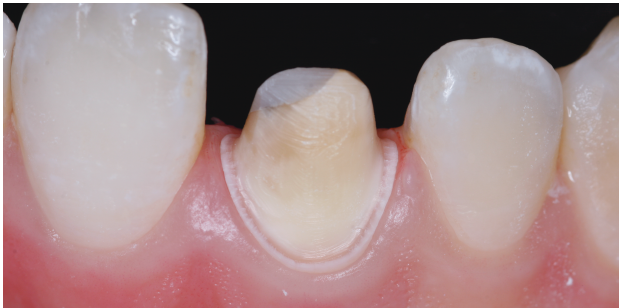
Fig. 9: The Racegel was rinsed away with no residue, leaving a dry, clearly exposed margin.

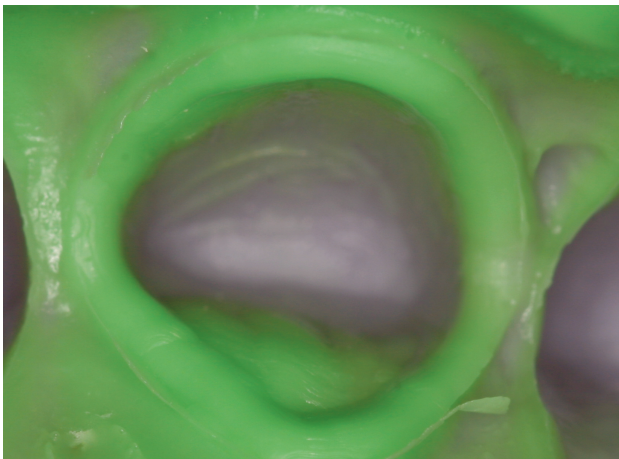
Fig. 10: The final impression. Note the 360° marginal capture.

This anterior crown preparation was associated with a thin gingival biotype and low bone crest. To keep tissue trauma to a minimum, Racegel was used as the only source of retraction (**Fig. 8**). After 2 minutes of setting, the material was easily rinsed away, leaving a clearly exposed margin (**Fig. 9**). The resulting impression had crisp 360° margins and captured past the margin end point (**Fig. 10**).

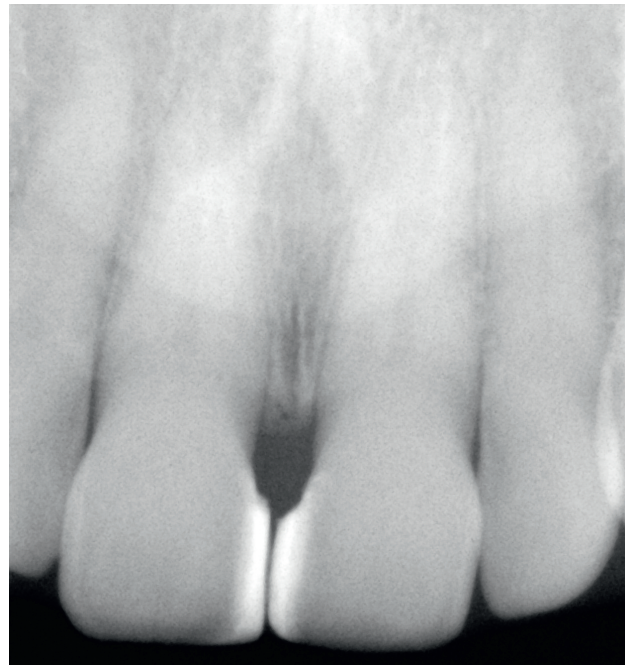
Fig. 1

The N'Durance[®] composite offers good handling characteristics, having a high viscosity and low feeling of stickiness during placement. In addition, it has a high opacity on radiographs, making it easy to differentiate it from tooth structure (*Fig. 1*).

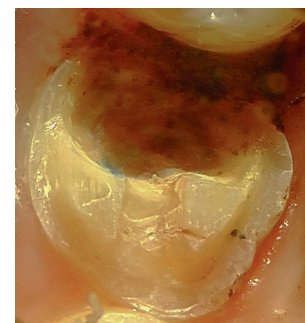
Fig. 5

extra care to avoid undercuts (*Fig. 5*). Biodentine™ placement fully covering the prepared cavity, waiting at least 48 hours with Biodentine™, acting both as dentin substitute and as a temporary restoration, before continuing the restorative process at the next patient visit would be the conventional procedure. Based on previous experimental studies (Yapp et al. 2012, Tolidis et al. 2013), it was decided to immediately continue with the restoration process, after Biodentine™ placement and setting. Biodentine™ was applied, right after the cavity was formed. Biodentine™ was placed in a 2-mm thick layer at the deepest part of the cavity located mesially, covering the undercuts on the pulpal wall, was condensed and was protected from moisture and allowed to set for 12 minutes according to the manufacturer's instructions. Subsequently, Biodentine™ surface was finished with a low-speed carbide bur. Dentinal walls of the onlay preparation, which were covered with cement, were finished with a low-grit high-speed diamond

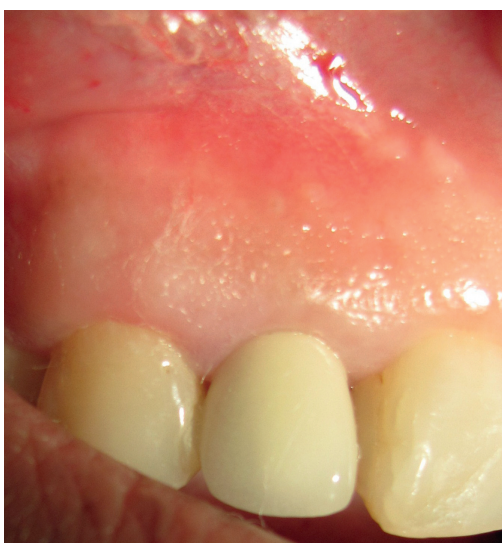
Fig. 1

We observed in the clinical examination that the tooth has a ceramic metal crown. No increase in the tissue volume was observed at the vestibular level (*Fig 1*), there is no sign of fistula, pain manifestation on palpation and vertical percussion.

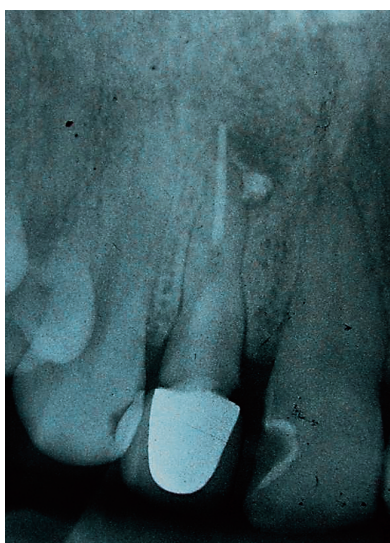
Fig. 2

The X-ray examination showed that the ceramic metal crown was not sealed at the cervical level, through the radiotransparency of the crown filling we noticed a fiber post, with absence of filling in the entire lumen of the canal prepared for the post, we also observed an over-obturation of approximately 3 mm and extravasation of the sealing cement, located in a radiotransparent area compatible with a chronic periapical process. (Fig 2)

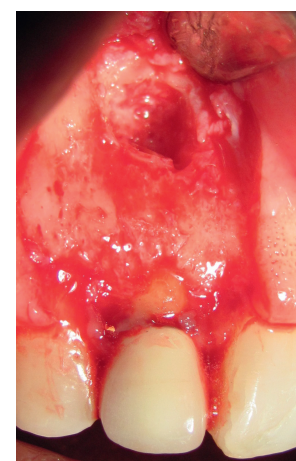
Fig. 4

curettage, the over-obtuated material and the surrounding granulomatous process was removed, and washed abundantly with saline solution to verify the removal of all the pathological tissue. The apicoectomy was performed with a fissure bur, creating as little bevel as possible and following the direction of the apical process. The apical chamber was prepared with a round bur following the direction of the root canal, at a 3 mm depth, it was thoroughly washed with saline solution and the cavity was dried with paper cones. (Fig 4)

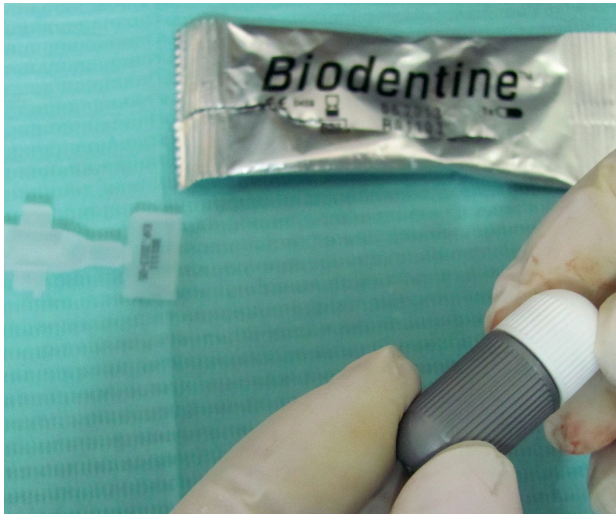
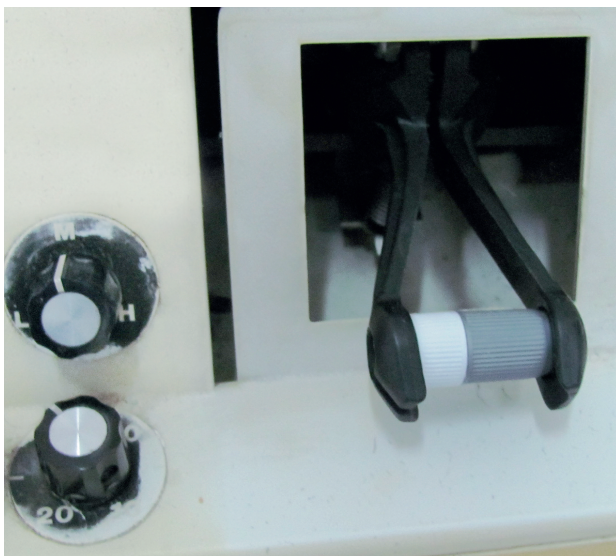
Fig. 5

Septodont's Biodentine™, an active biosilicate-based retrograde obturation material was prepared according to the manufacturer's instructions, mixing 5 drops of the liquid (Aqueous calcium chloride and excipients solution) with the powder

(tricalcium silicate) for 30 seconds in the Henry Schein amalgamator Model: HS-1. (Fig 5, 6)

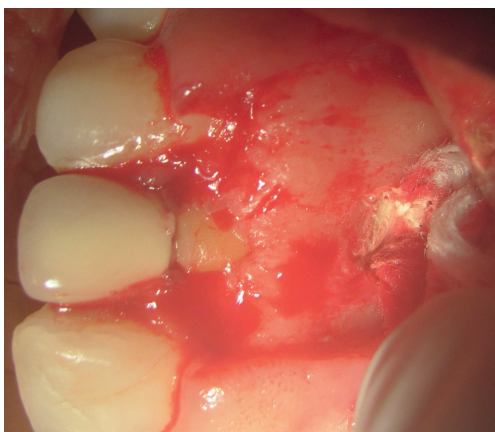
Fig. 7

We then placed the appropriate amount of material in the prepared cavity and condensed it, after 12 minutes, completely isolated from fluids, according to the manufacturer's recommendation (Fig 7), the excess was removed. (Fig 8)

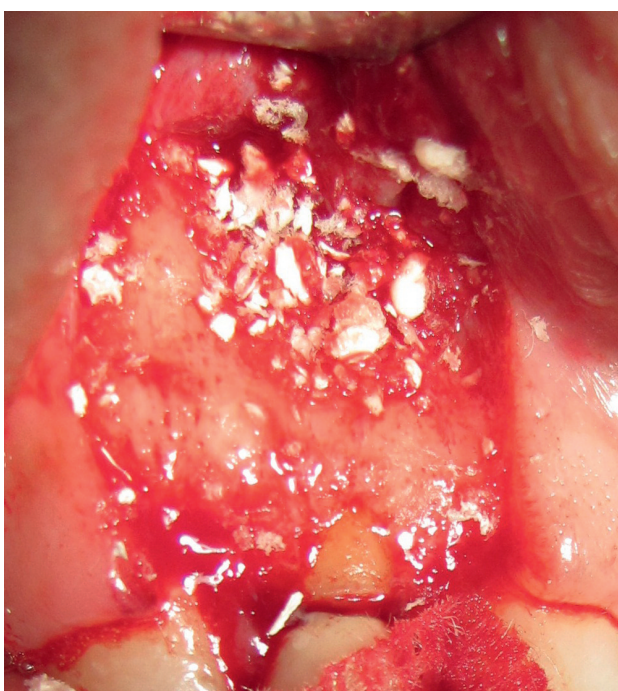
Fig. 9

We placed Genox® Org Genius-Baumer bovine liophilized bone in the cavity to fill-in the bone defect. (Fig 9)

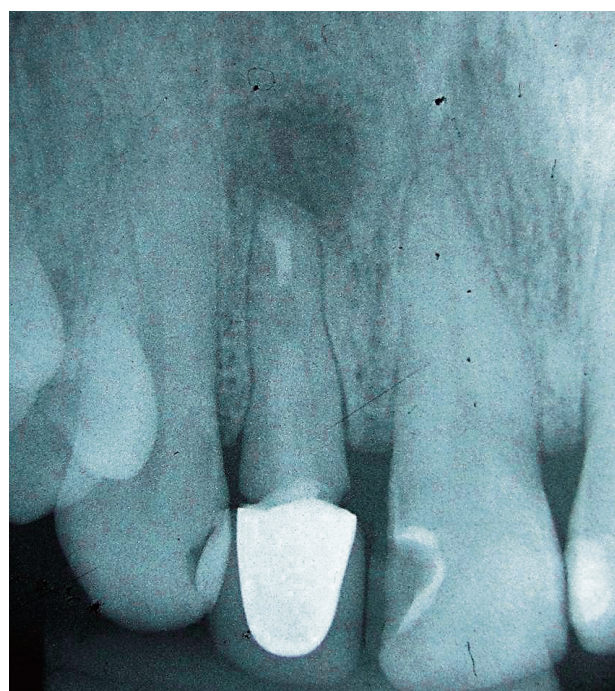
Fig. 10

We closed with 3-0 black silk suture, and treated with amoxicillin plus clavulanic acid 500 mg, every 8 hours for 7 days and ibuprofen 400 mg every 8 hours for 4 days, as well as recommending a 0.12% Chlorhexidine Gluconate mouth wash 3 times a day for 7 days. A control X-ray was taken. (Fig 10)
